**The Sheafhouse, Sherborne – A Grade II Listed Building (photos taken on 29-07-2026)**

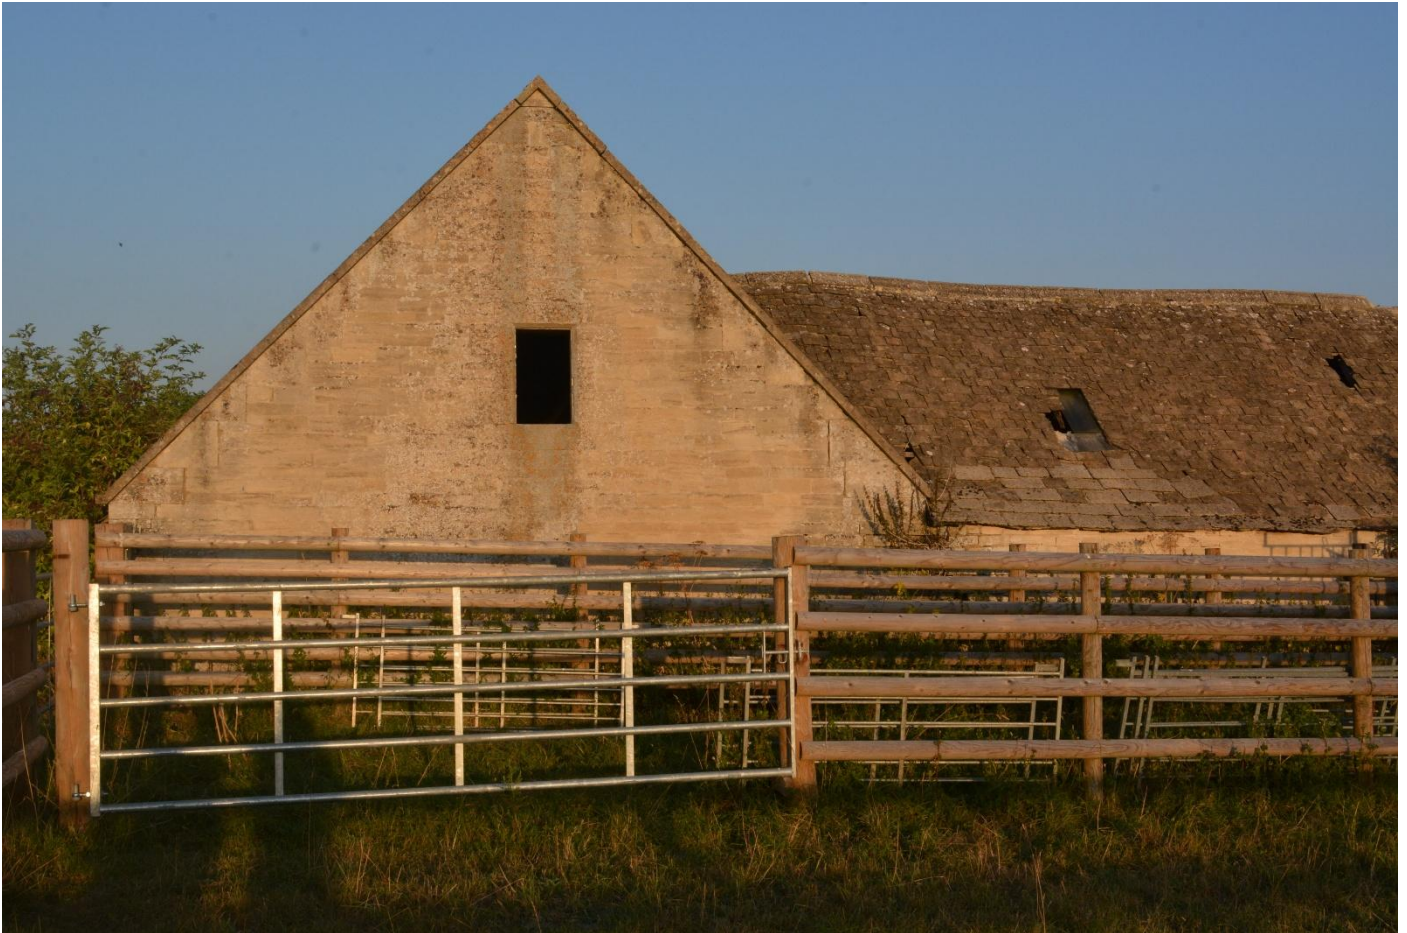
Gable on the western elevation. Note open skylight and concrete replacement slates to the right of the gable.

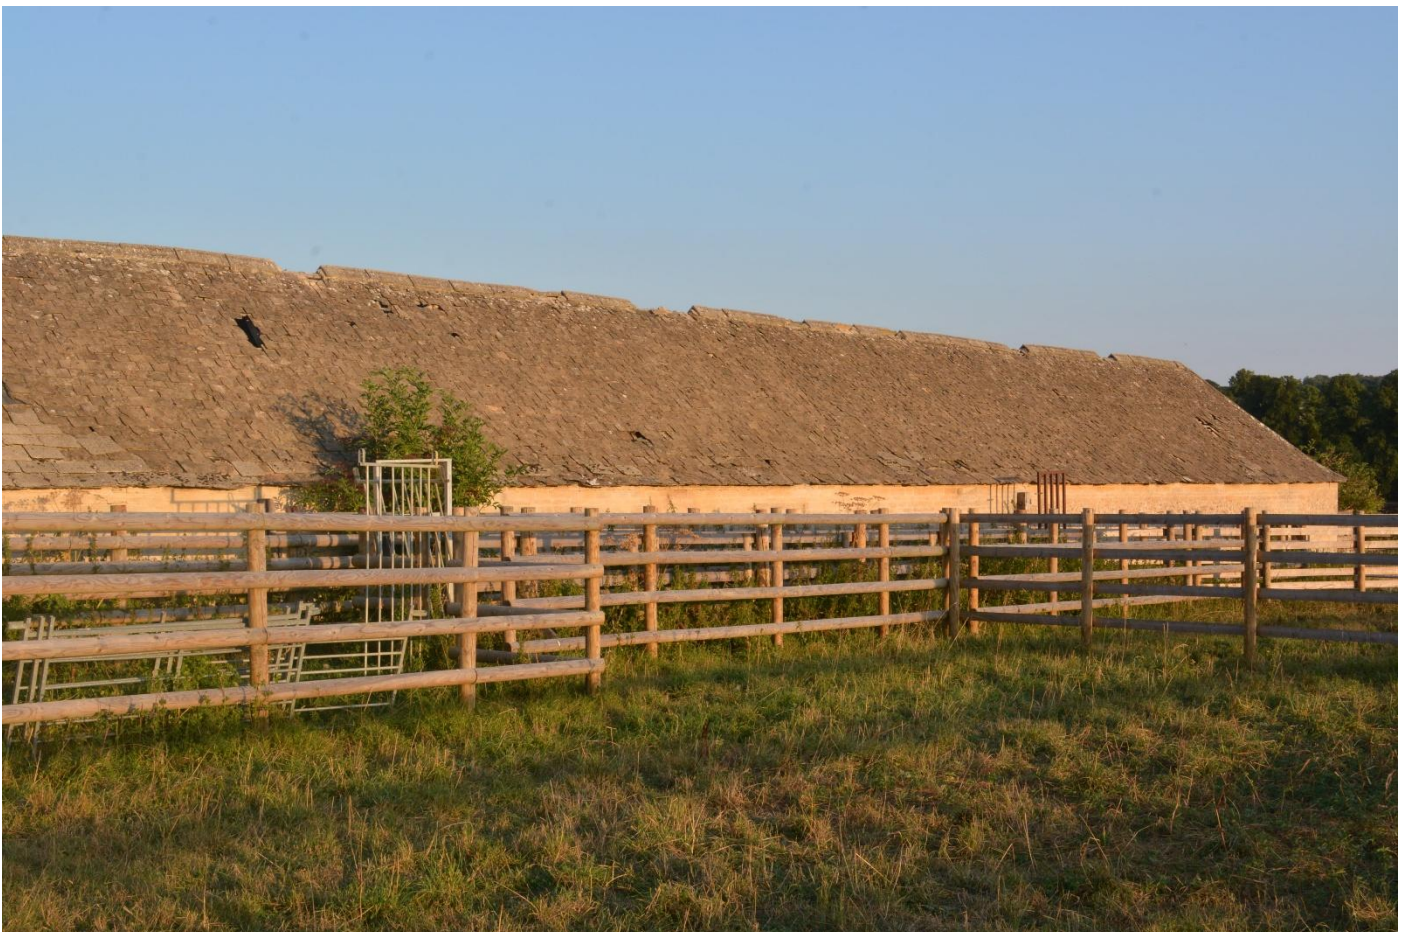
Western elevation. Note holes in the roof, missing / slipped slates and missing ridge tiles.

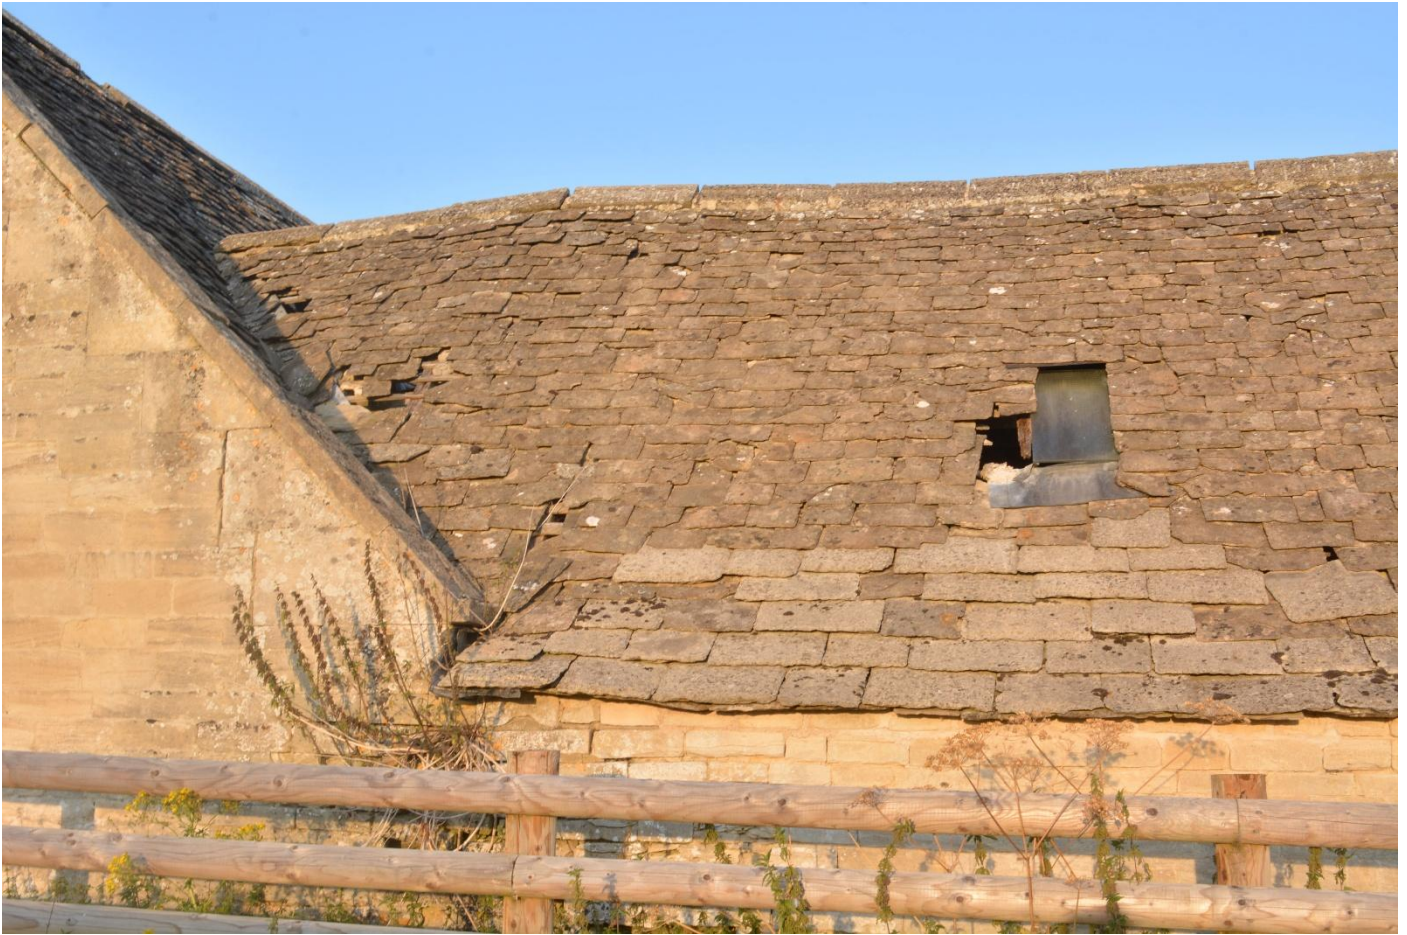
Western elevation roof deterioration: missing slates, open voids, collapsed ridge, replacement concrete slates.

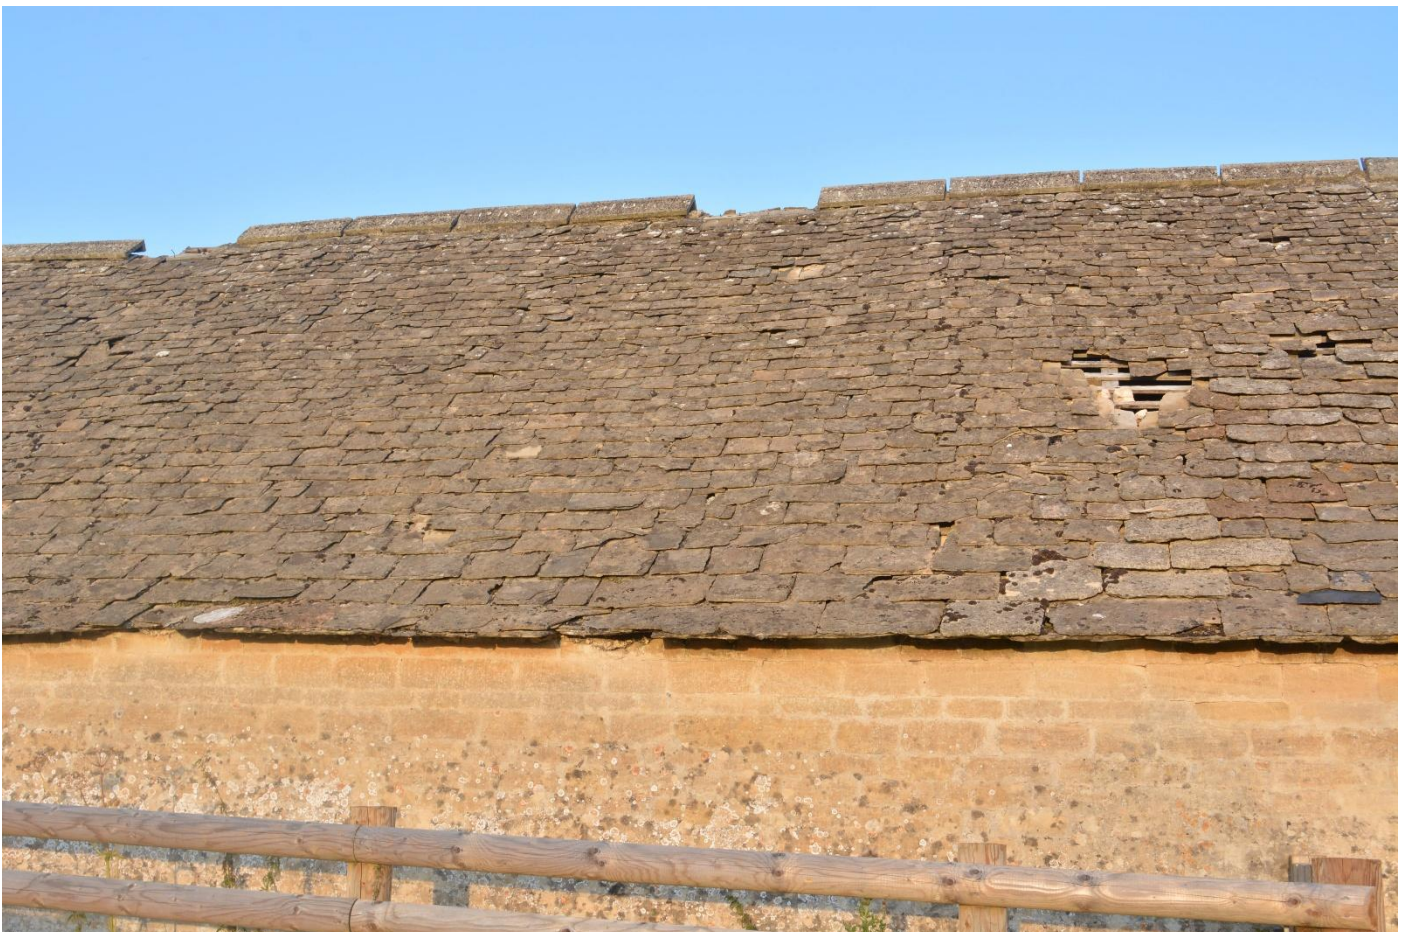
Western elevation roof deterioration: as above and missing ridge tiles.

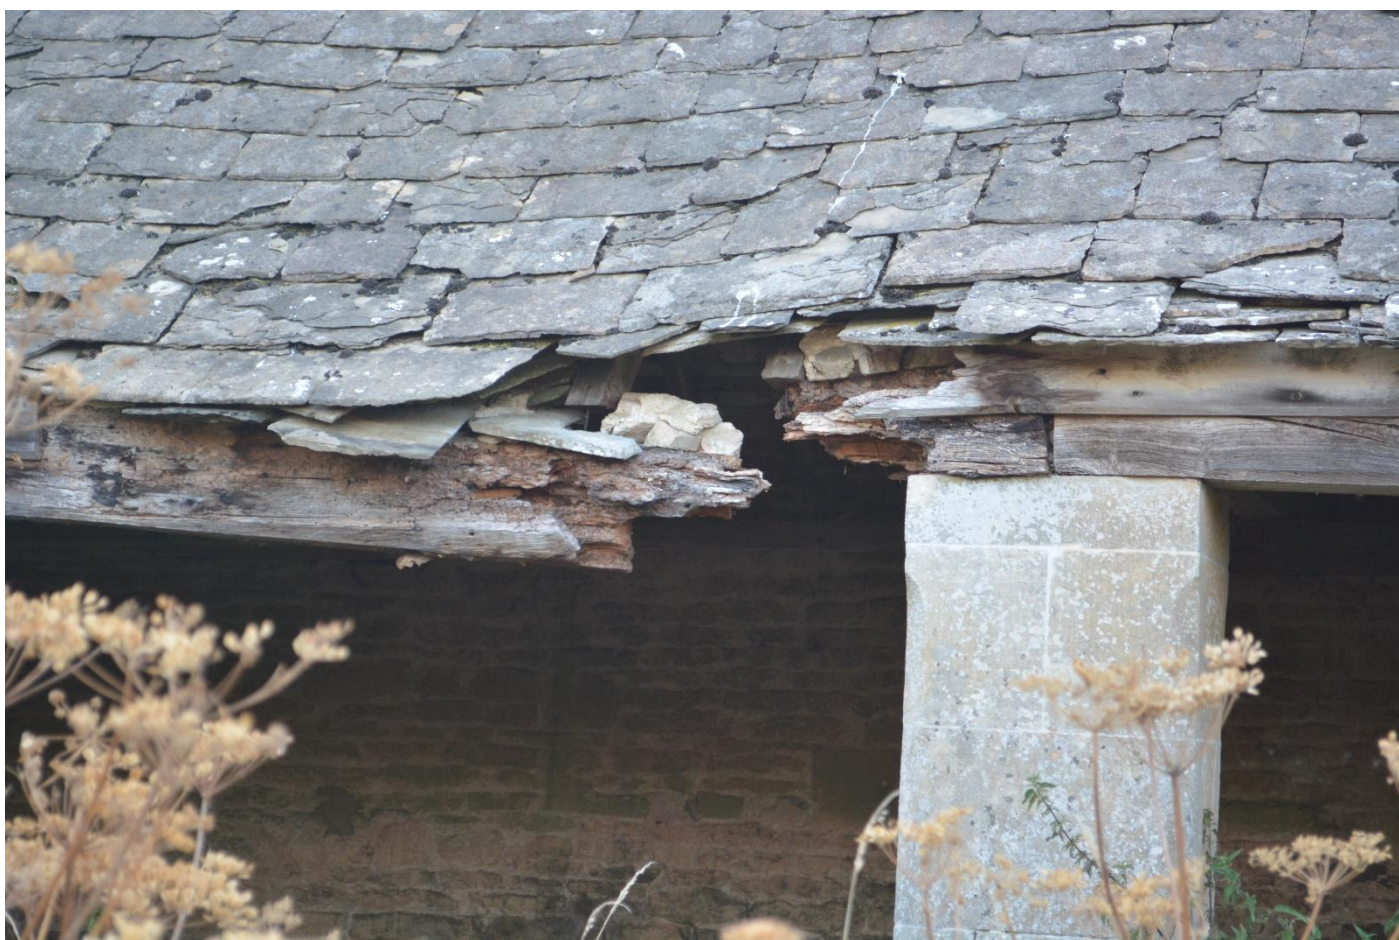
East facing elevation on interior courtyard showing rotten and collapsed timber lintel between stone piers.

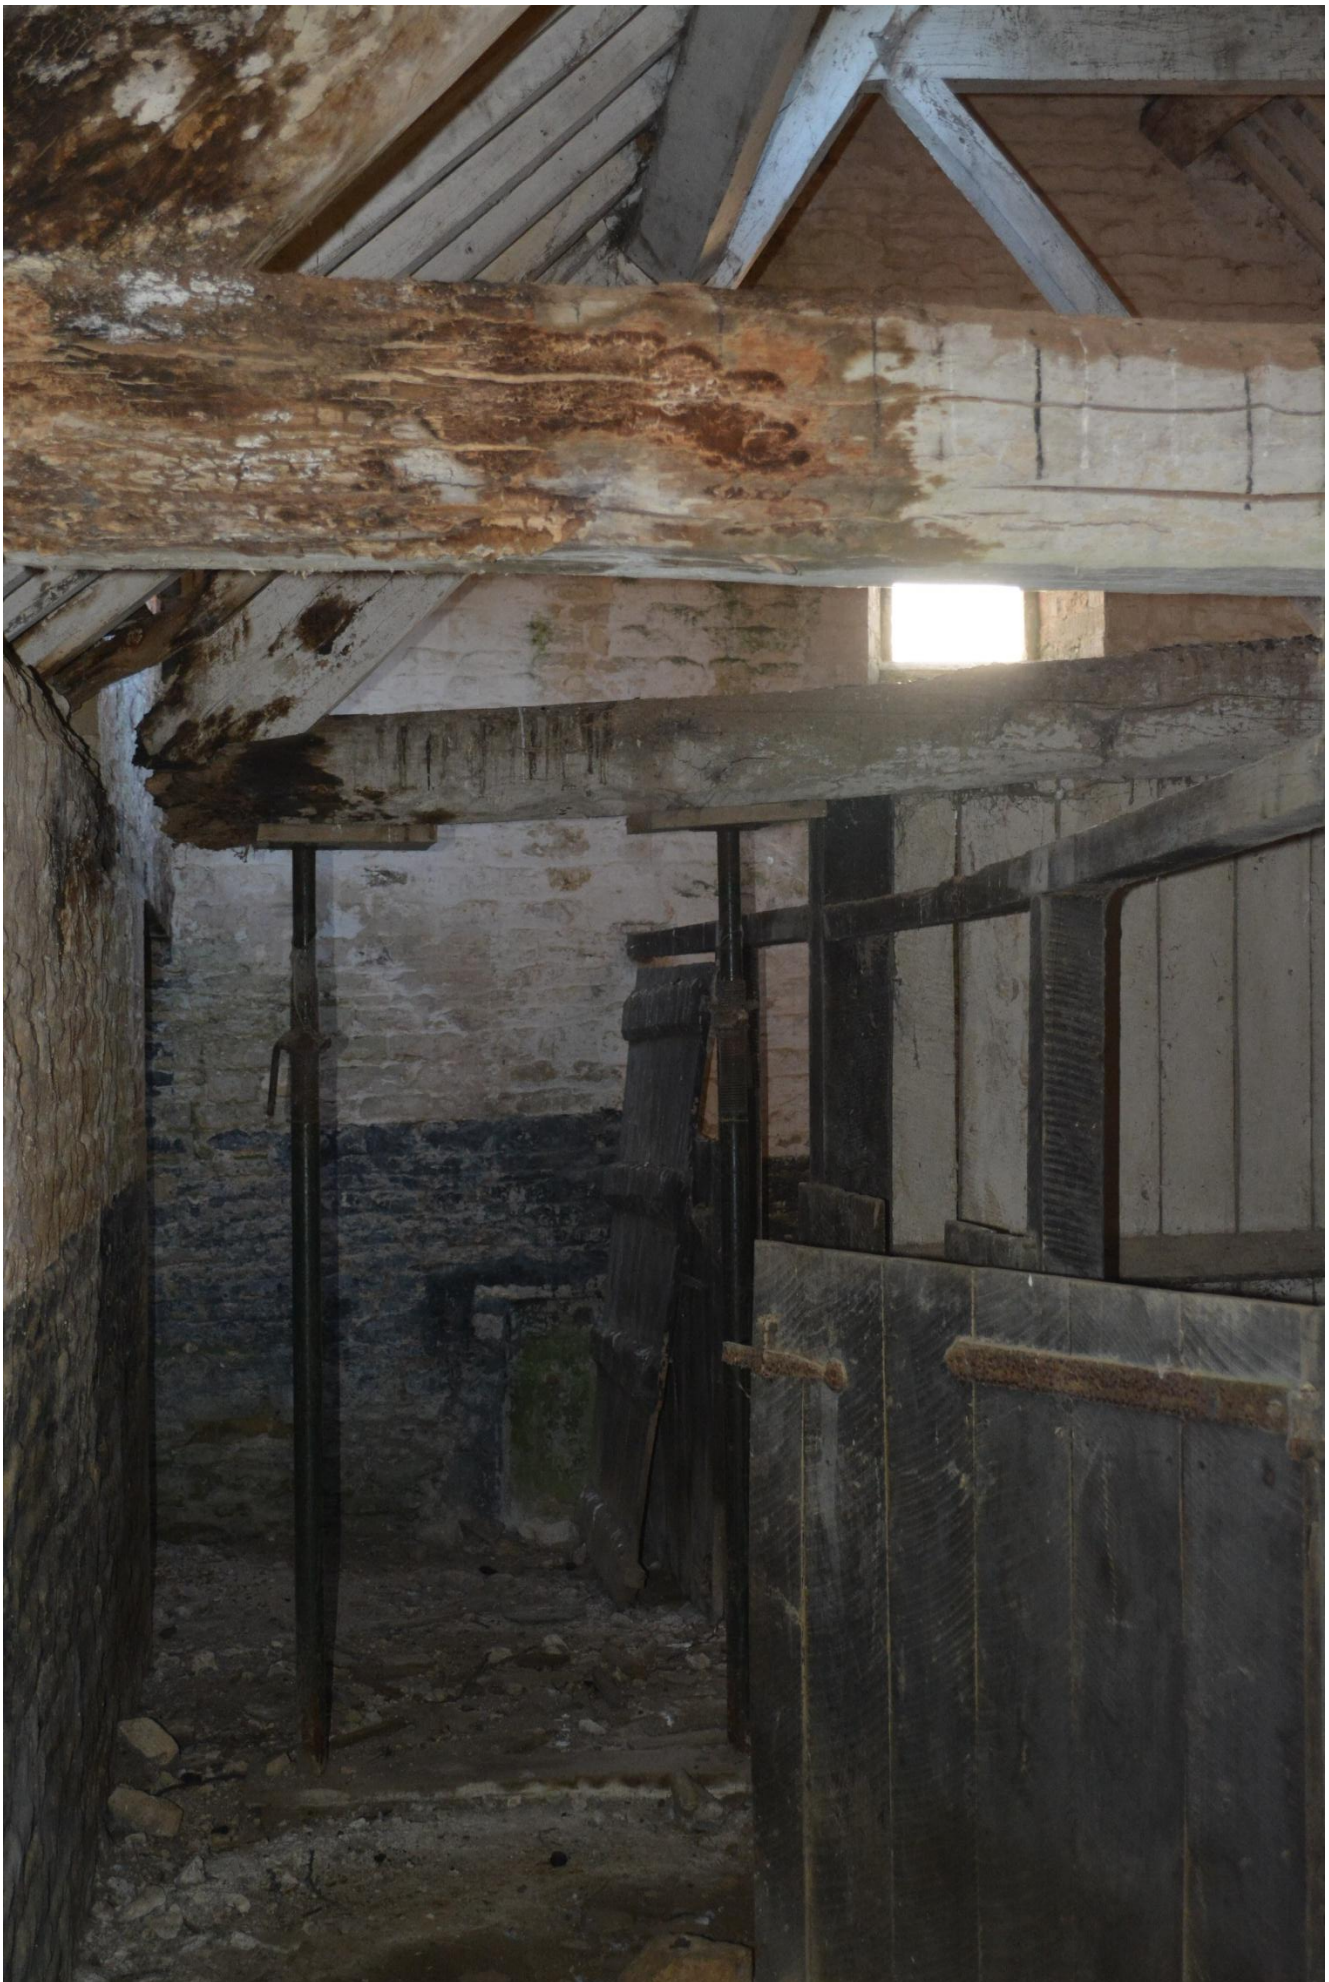
Interior detail: western end of northern barn showing collapsed roof truss.

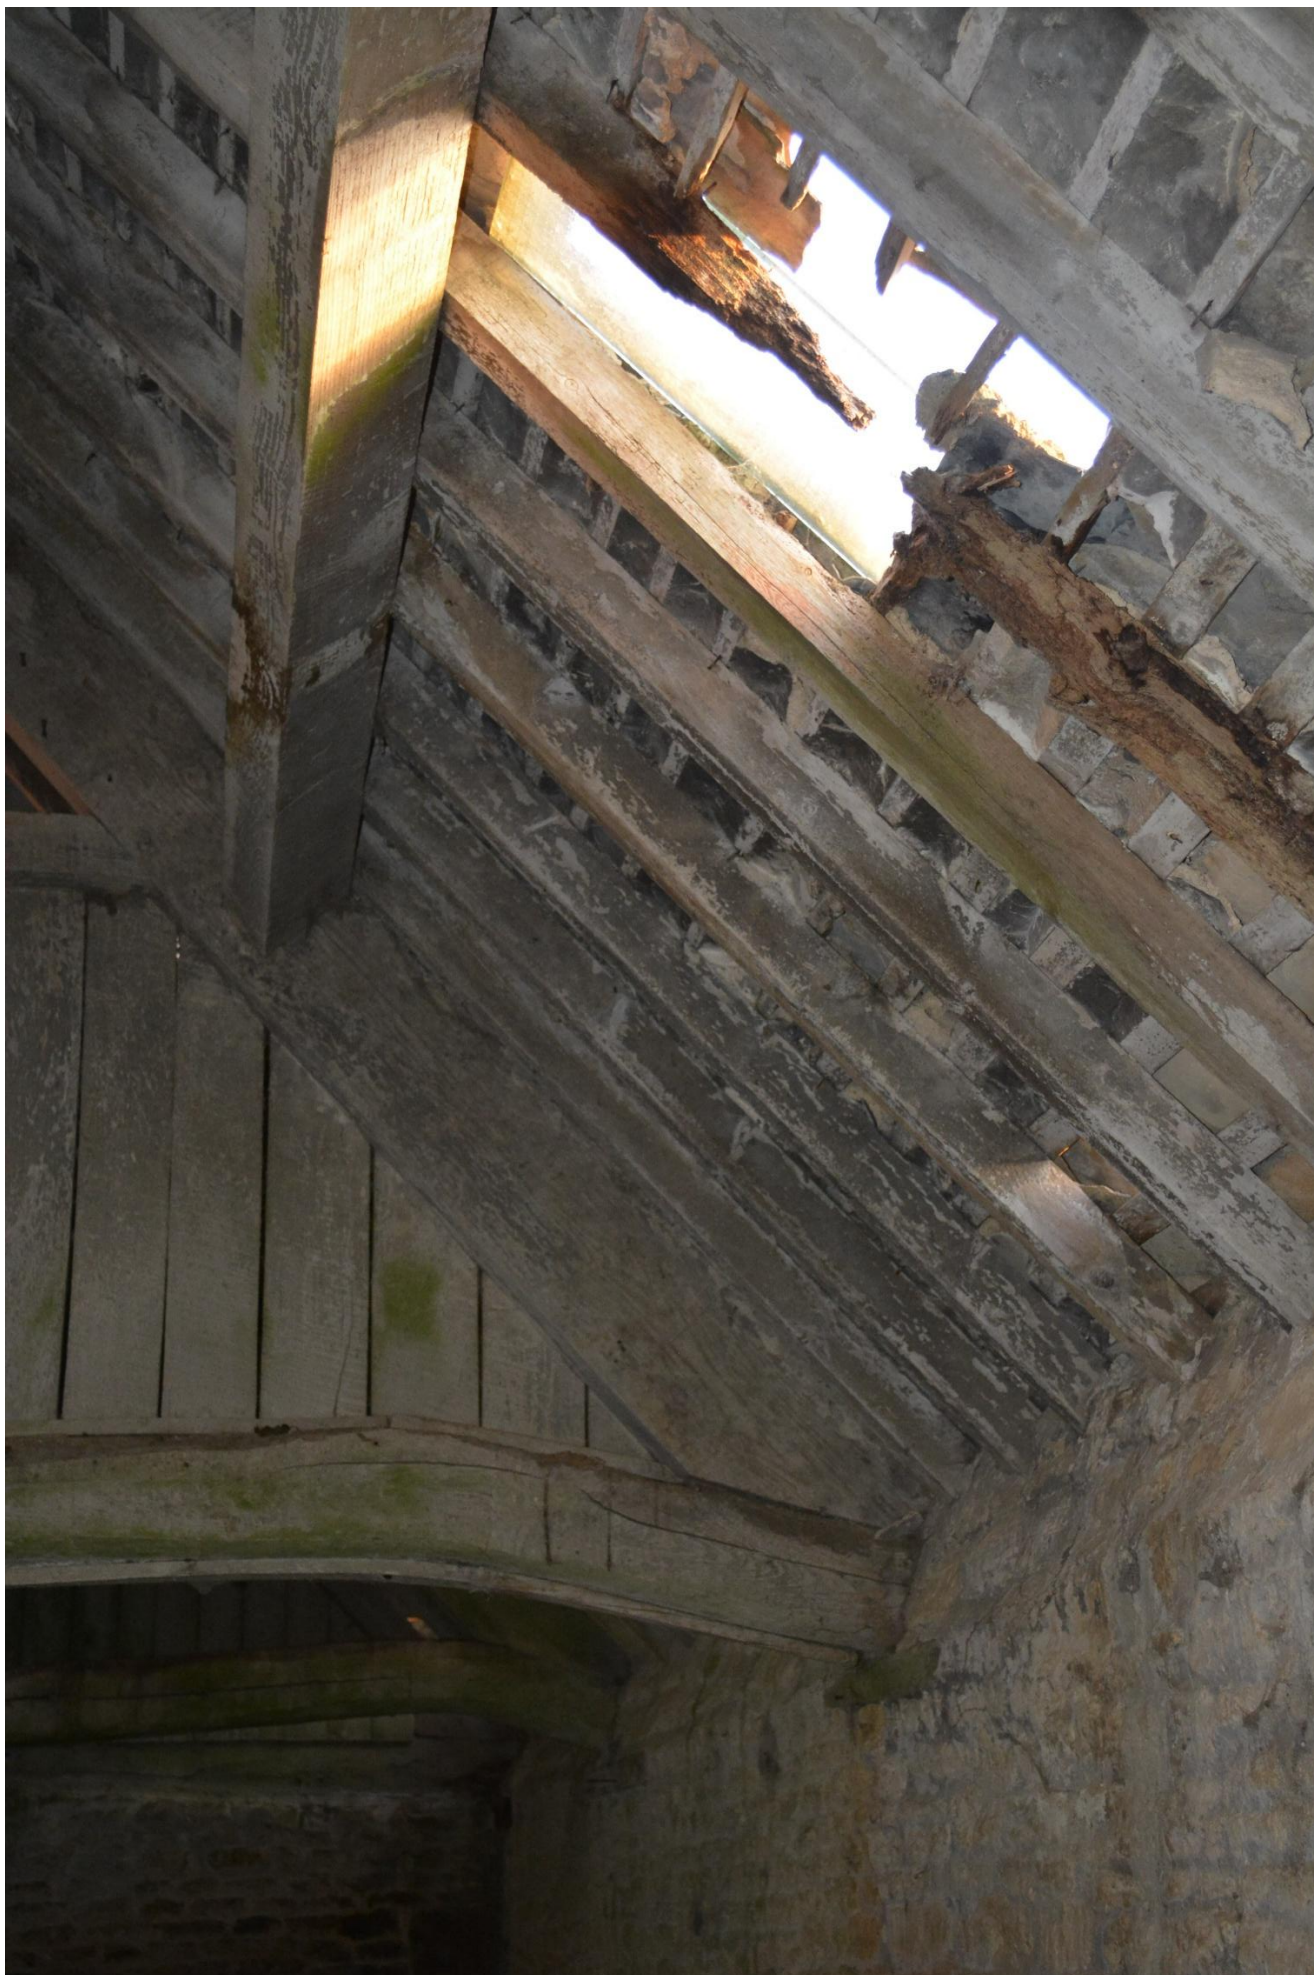
Interior detail: west facing roof of western barn showing rotten rafters and open void. Note original roof Trusses with curving tie beams.

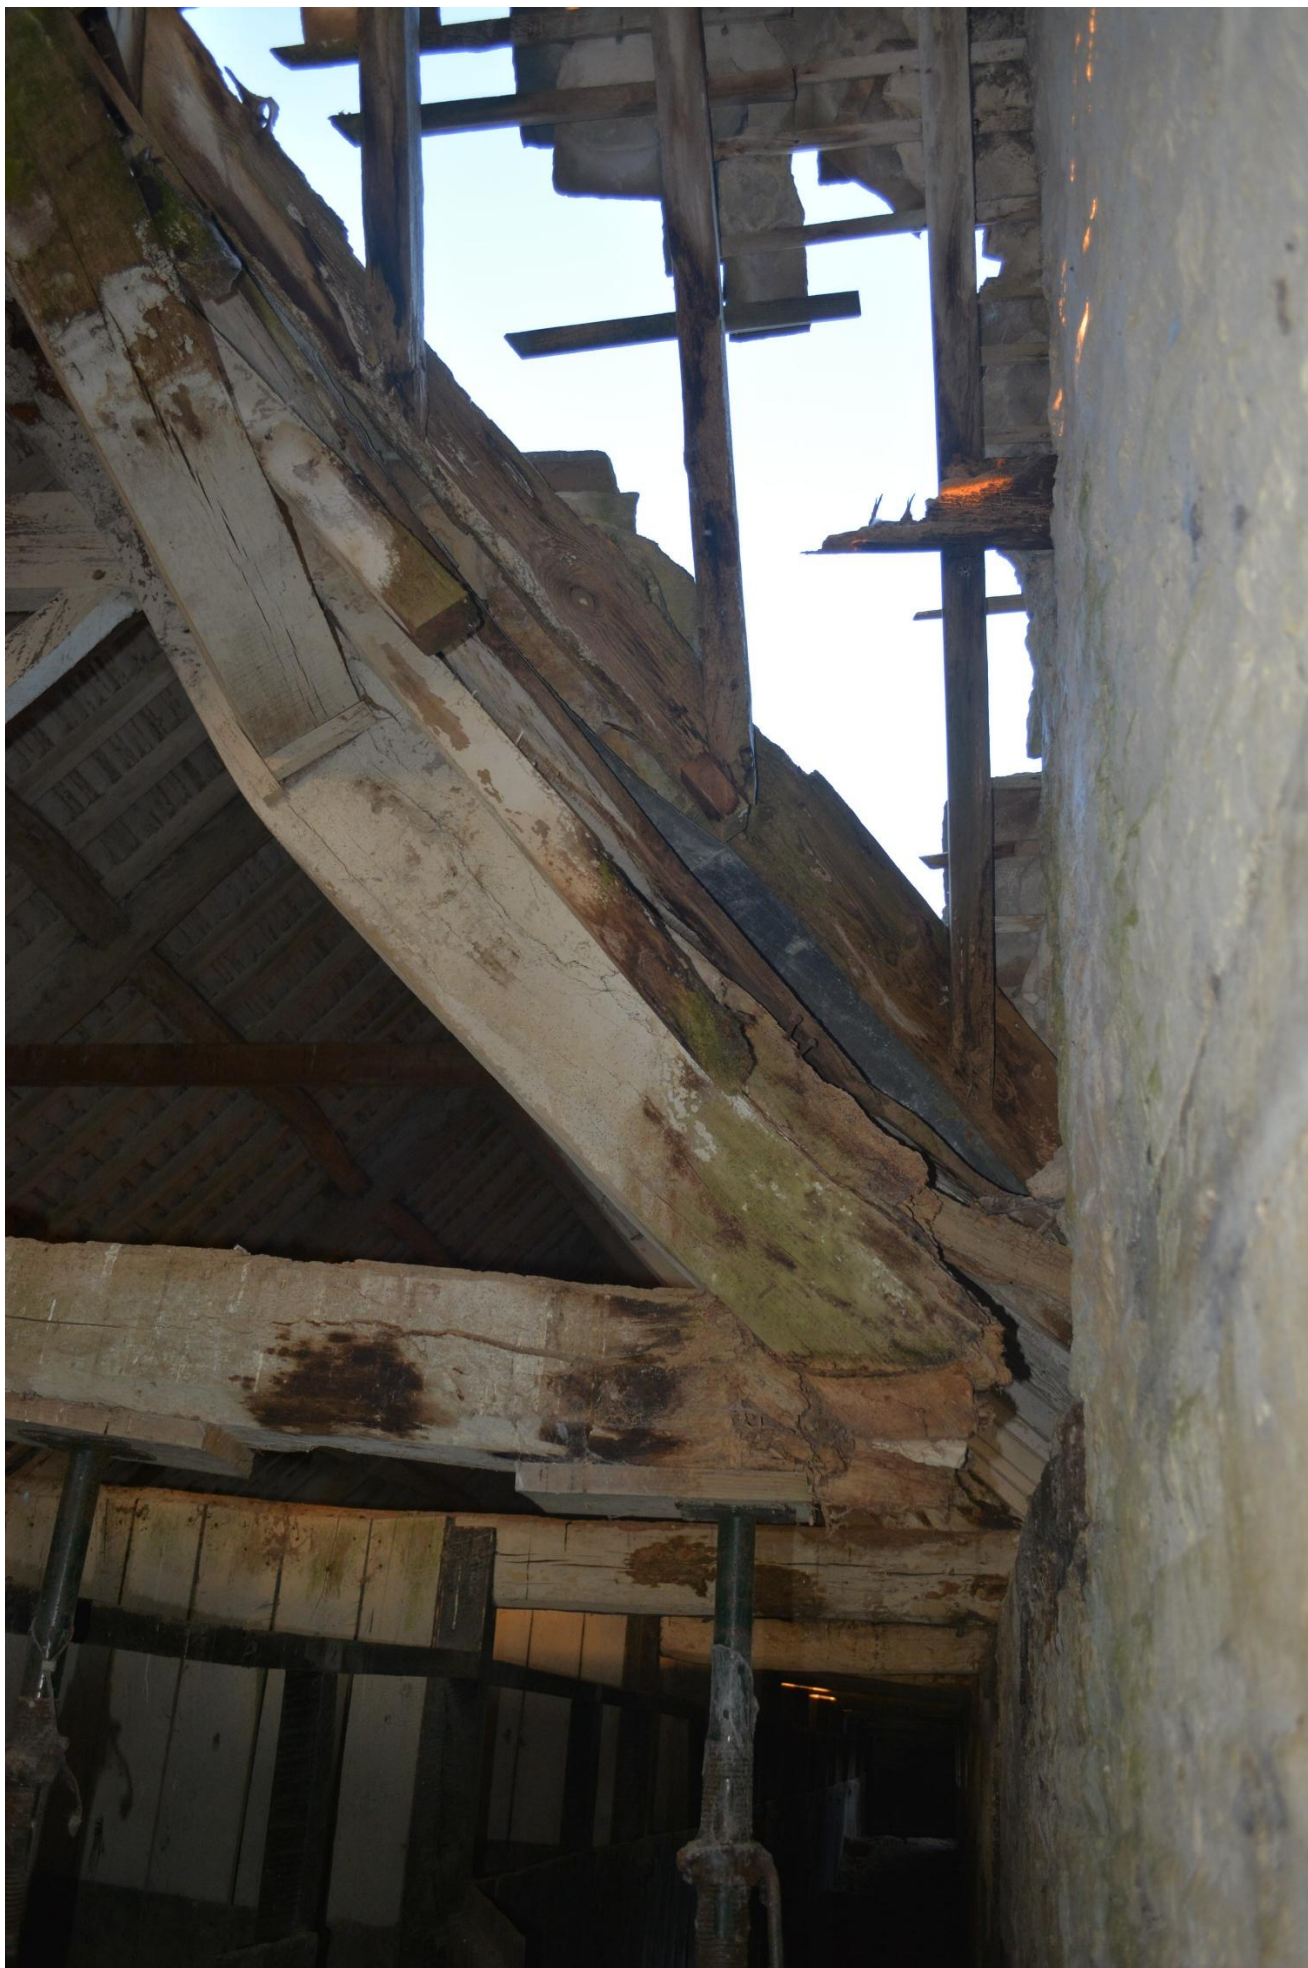
Interior detail: south facing roof of northern barn showing rotten and collapsed roof truss and open void.

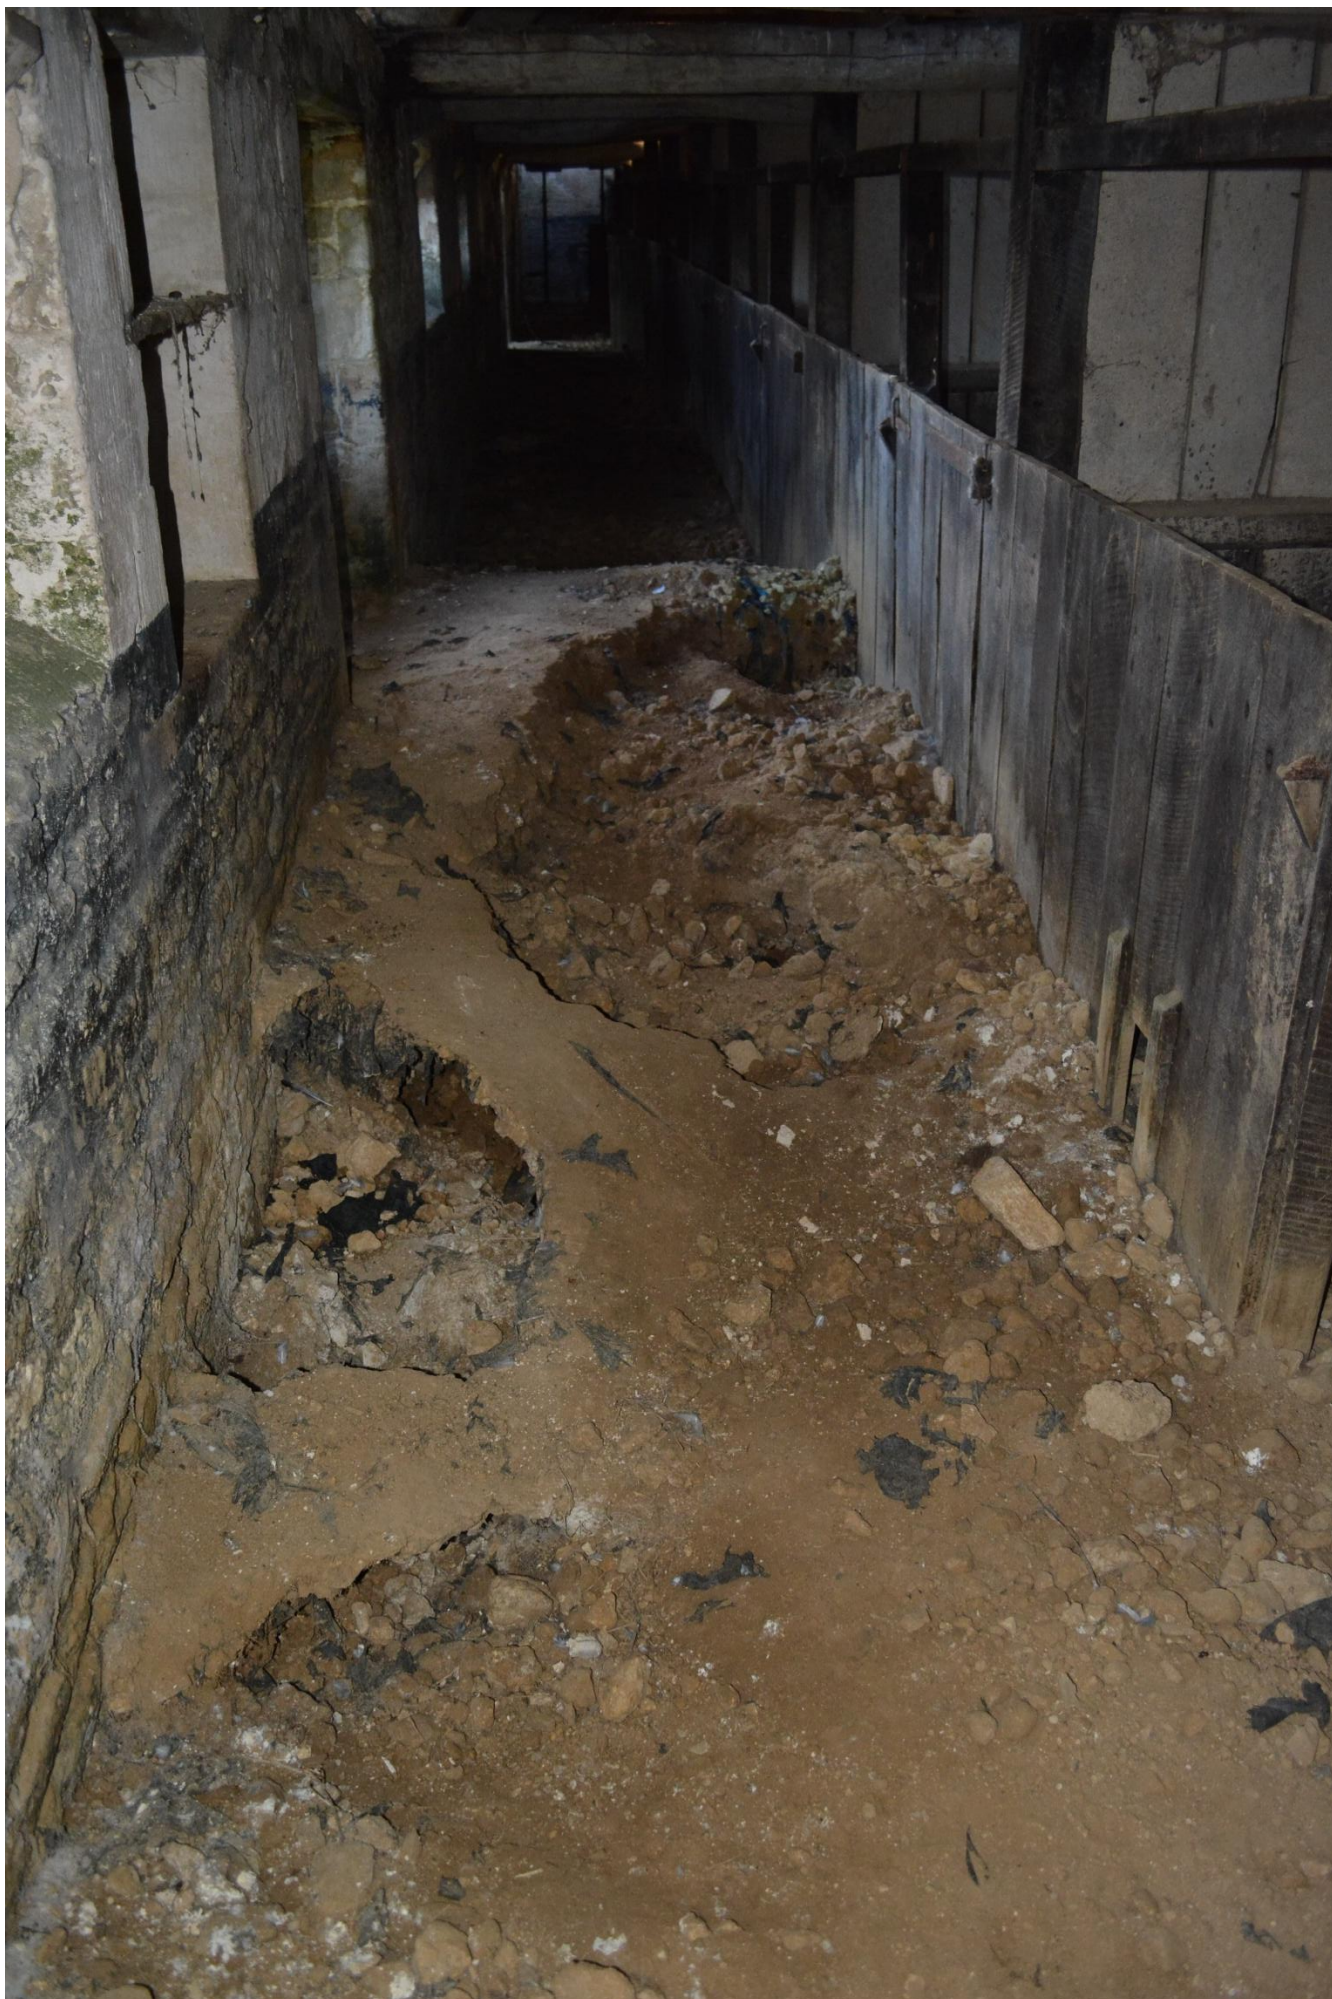
Interior detail within the northern barn showing active badger sett and excavations within the floor. Note the original timber stalls to the right.
